PUBLIC NOTICE:
Proposed No Further Action Determination

SIERRA LUMBER CASE #1 & CASE #2
375 W. Hazelton Avenue, Stockton, San Joaquin County
Case #390257 & #391168
GeoTracker Global IDs:
T0607700185 & T0607726897

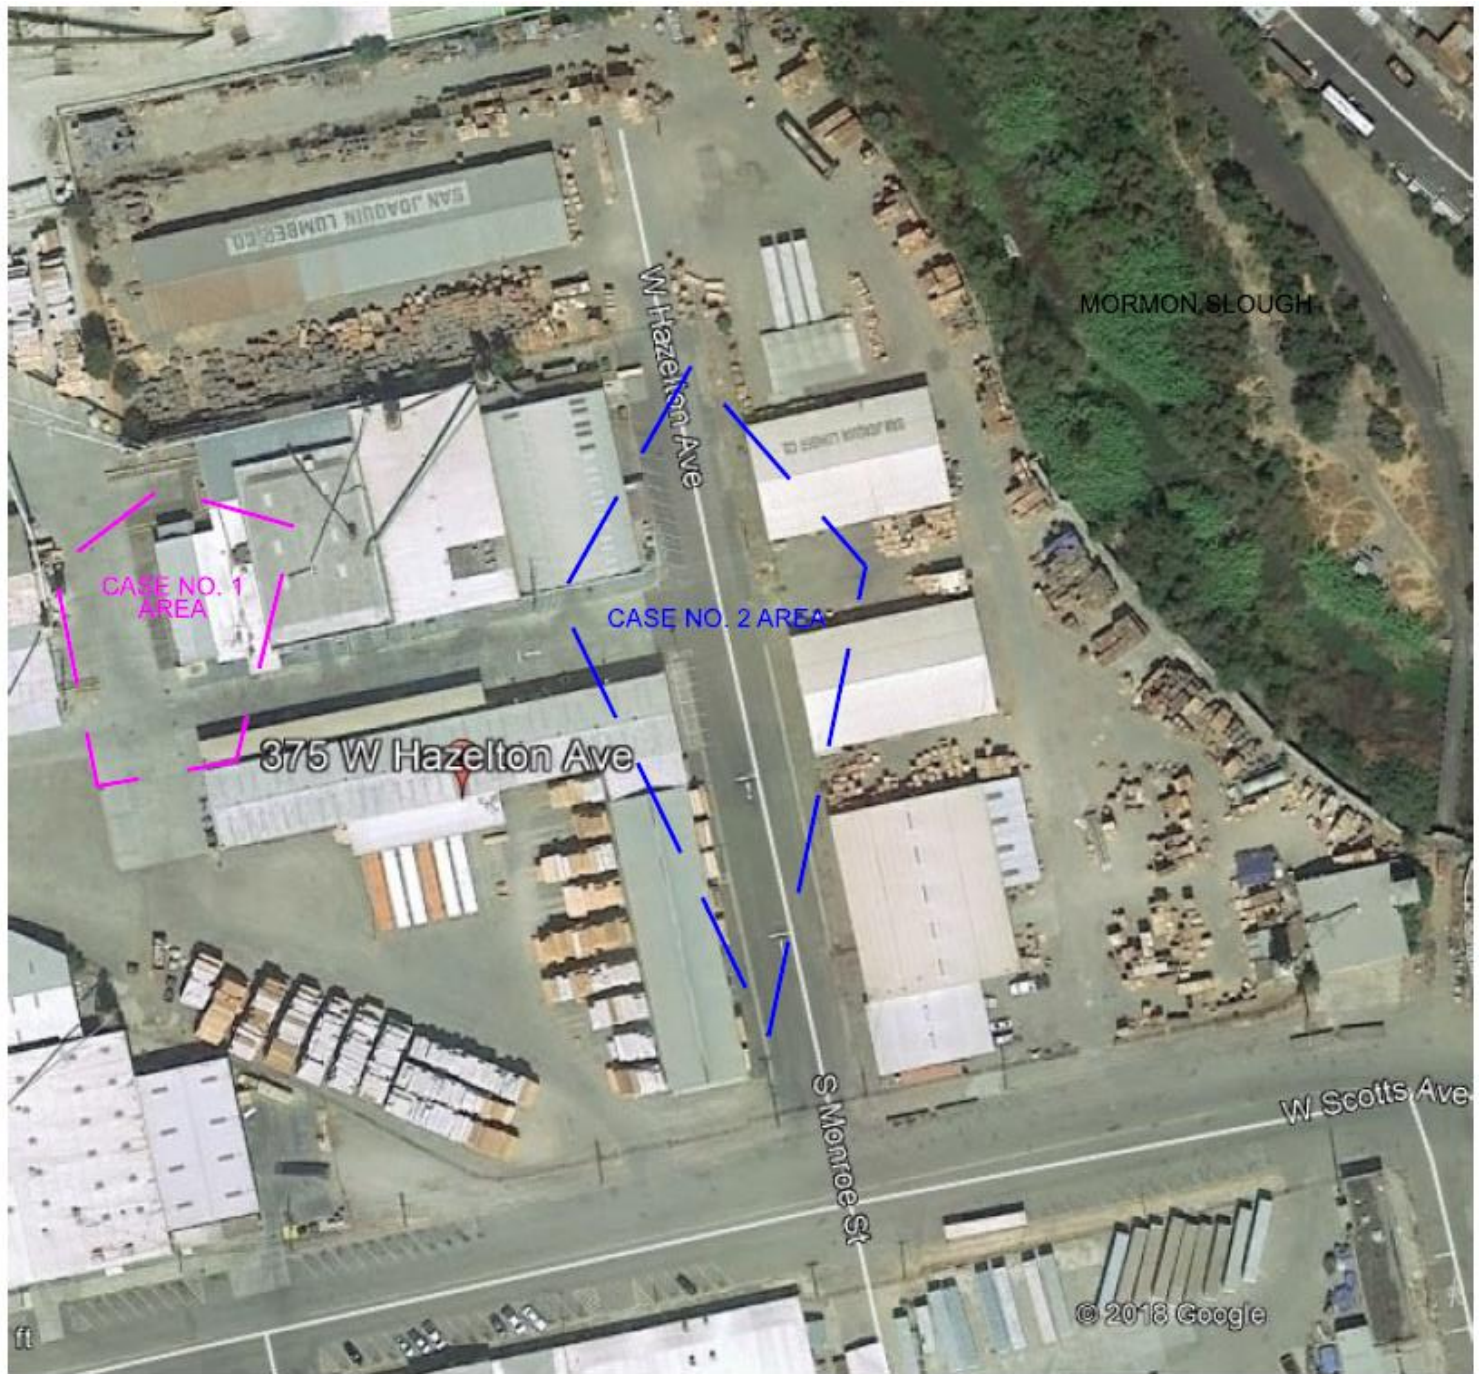
FIGURE 1

Figure 1 – Site showing the Site Location and Case #1 and Case #2 investigation areas

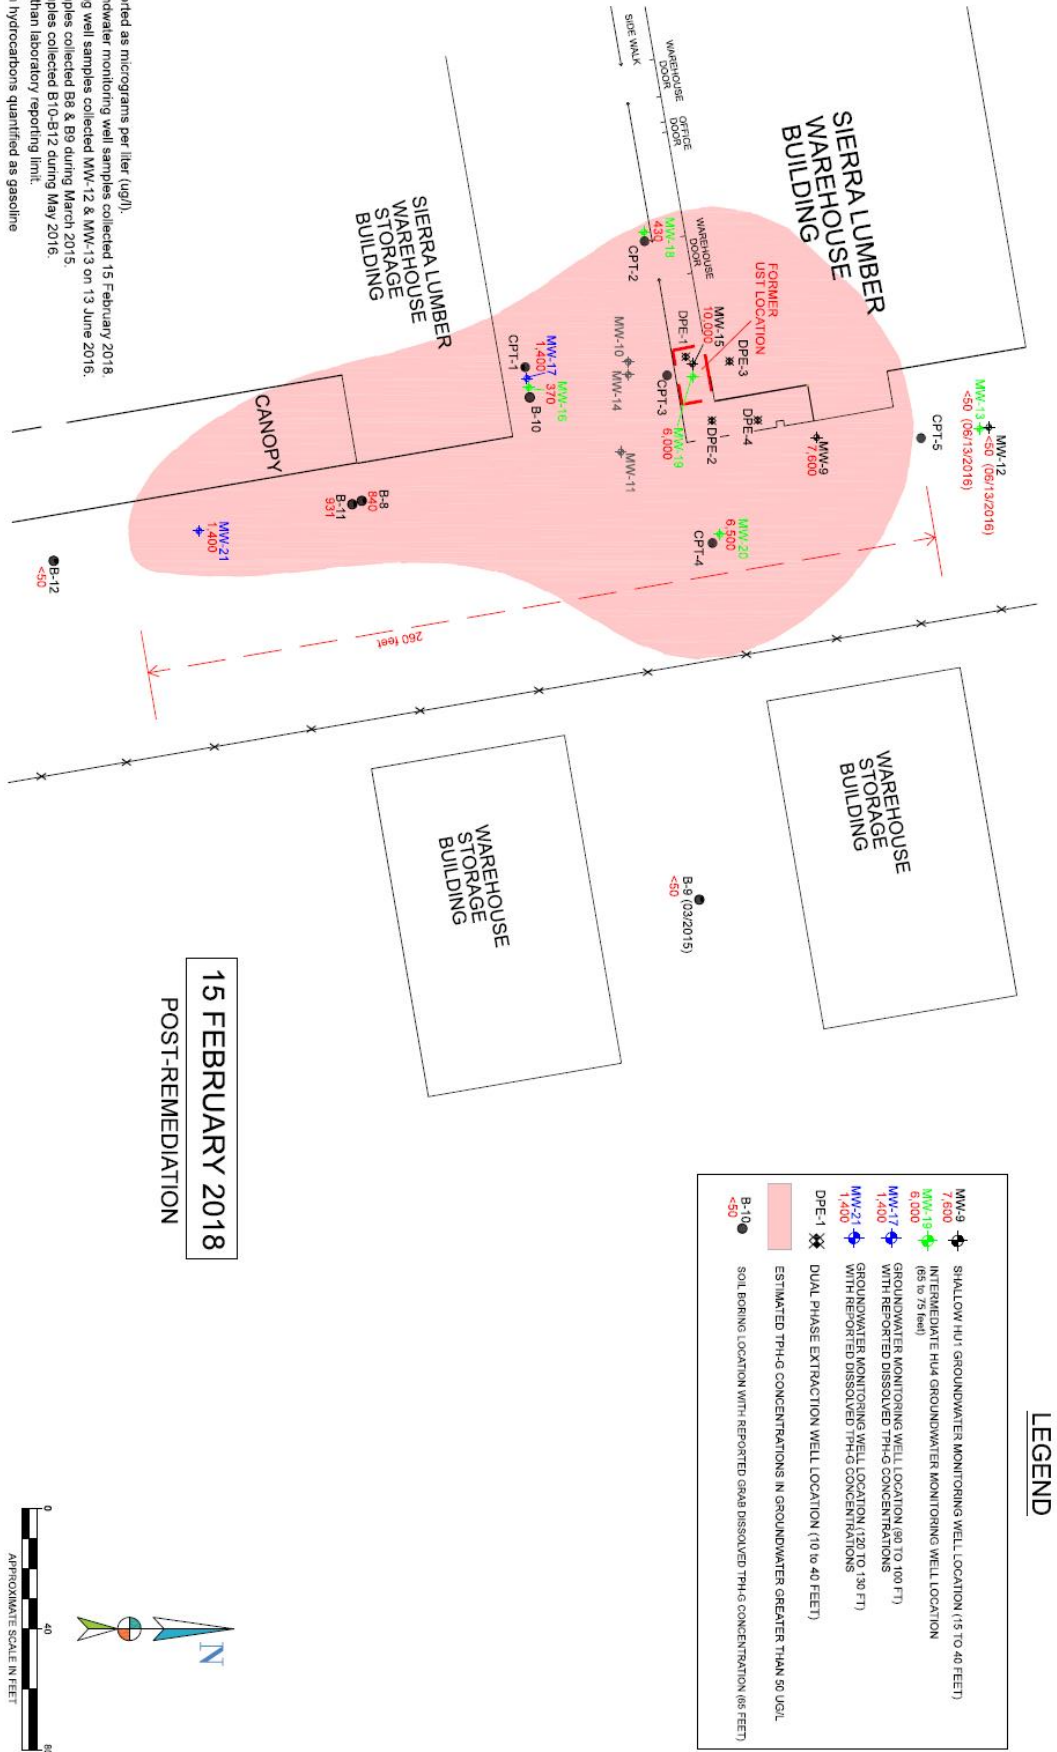
FIGURE 3

Figure 3 – Site Map showing the Case #2 current remaining extent of petroleum impact to groundwater above water quality objectives

The Central Valley Regional Water Quality Control Board (Central Valley Water Board) invites public comment on the proposed No Further Action Determination and closure of both Sierra Lumber Case #1 and Case #2 underground storage tank cases, located at 375 W. Hazelton Avenue in Stockton, CA (Site). A map showing the location of the Site and the Case #1 and Case #2 investigation areas is attached (Figure 1). Maps showing the current remaining extent of petroleum impact to groundwater in the Case #1 and Case #2 areas are included as Figures 2 and 3, respectively.
